ZEN SERIES

ZEN-7000 ZEN-2090^{Turbo}

Classic but Powerful
Genoray's Accumulated Technology
Stable and Durable

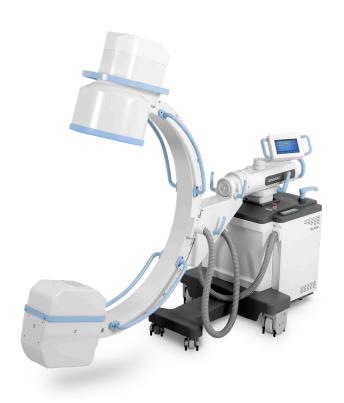
ZEN-7000

Durable, Powerful I.I. C-Arm

- 15kW HFG
- Image Intensifier (9"/12")
- 135° wide orbital rotation
- DSA (Angiography, Road map, Post processing)

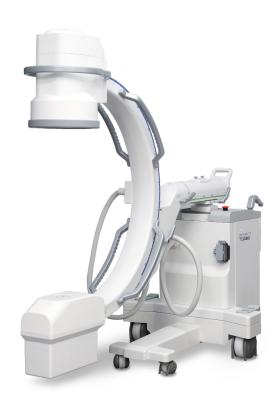
ZEN-2090 Turbo

Compact, Efficient I.I. C-Arm

- 2.0kW HFG
- Image Intensifier (9")
- High-Level Fluoroscopy mode
- Compact / light-weight for easy movement

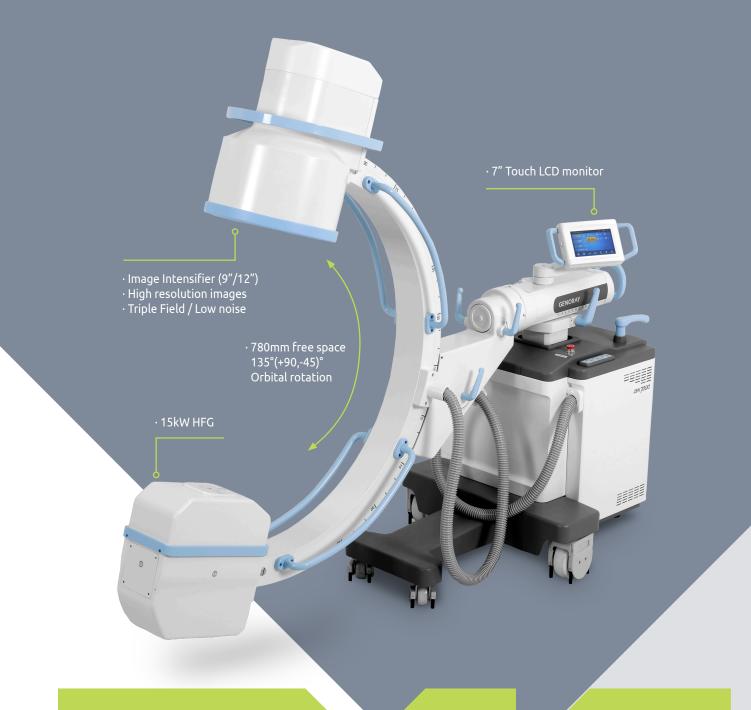
ZEN-7000 offers various operations with high quality images with choices of 9"/12" Image Intensifier and 15kW HFG. It is an internationally steady selling powerful C-Arm from Genoray.

9"/12" Image Intensifier

· High Resolution Images 1k x 1k Pixel

HFG

· 15kW HFG

DSA

- · Angiography
- · Road Map
- · Post Processing

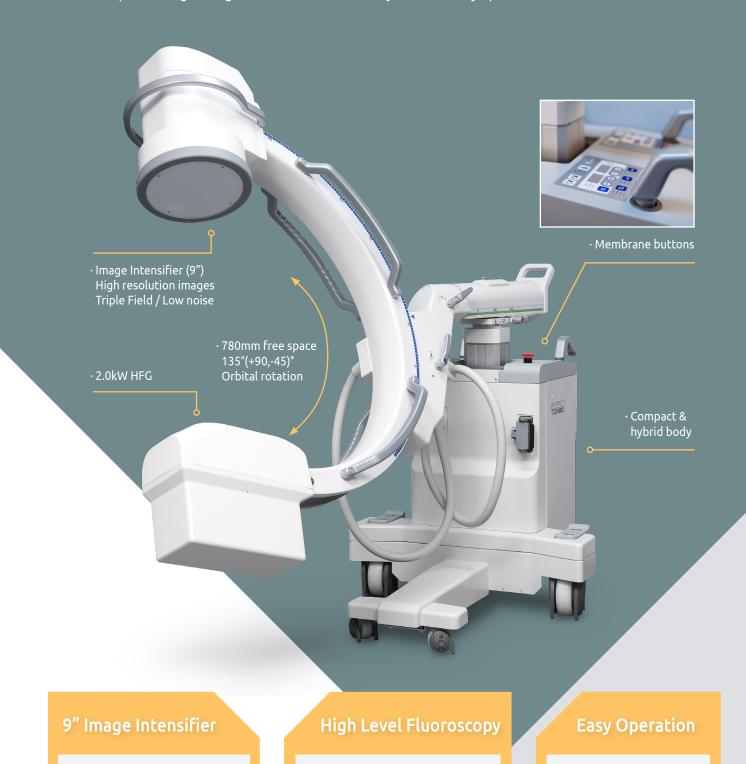
ZEN-2090 Turbo

ZEN-2090Turbo is the best standard C-Arm with high quality images for perfect diagnosis. Its compact and light-weight dimension makes it easy to use for any operations.

· High Resolution Images 1k x 1k Pixel · Low Noise Optimum Image Quality · Light-Weight Wide SID High Range of Rotation

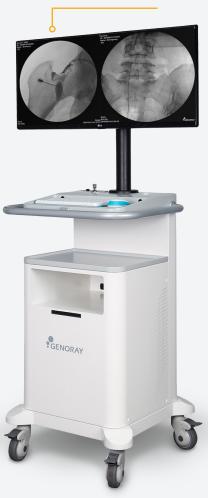
ZEN-2090 Turbo

Monitor Cart

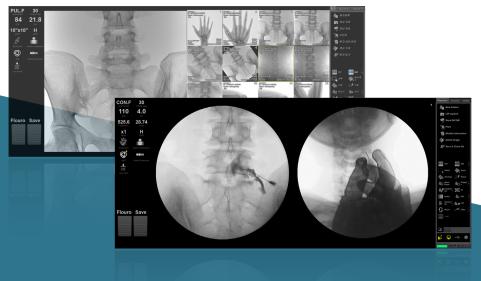
Powerful Software, ZENIS

A total solution provides convenient environment for acquisition, storage, management, communication, and print out with user-centric interface.

Diagnosis and confirm from recognizable simple icons / Convenience of database management

Image Management Invert, rotation, zoom In/out, magnifying glass and etc.

Measurement & Annotation

Measurement of length and angle
